Thermal Imaging for Improving Energy Conservation Behaviors: An Infrared Thermography Survey for Residential Buildings

Husein Ali Husein^{1*}

¹Department of Architecture, College of Engineering, Salahaddin University-Erbil, IRAQ.

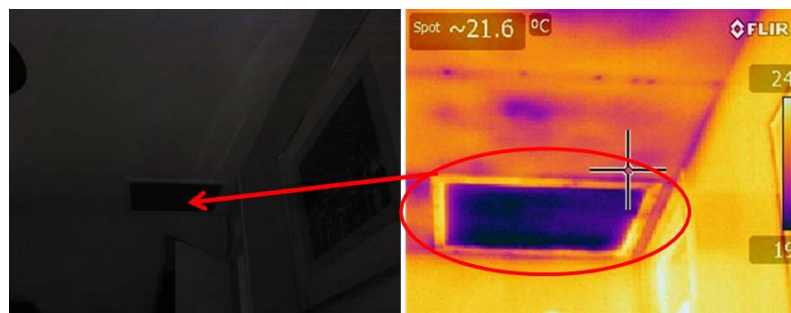
Figure 12: The small opening to the loft level creates a thermal bridge

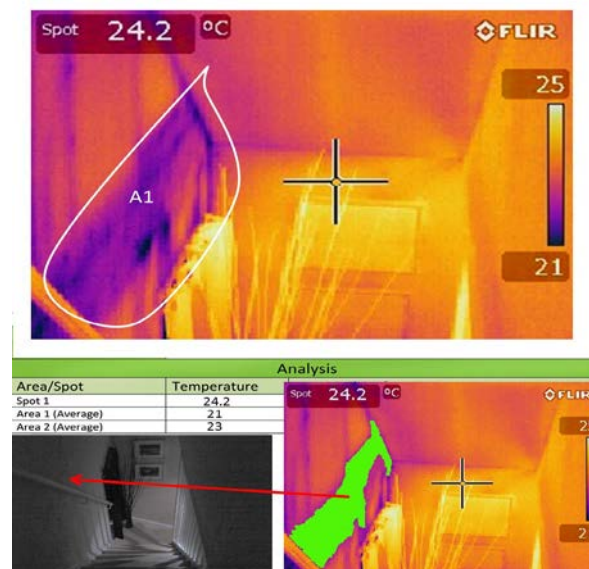
Figure 13: the defects on the staircase wall

The green highlighted isotherm in the infrared image (Figure 13) shows the area where the surface temperature is below critical surface temperature which is on average 24°C.

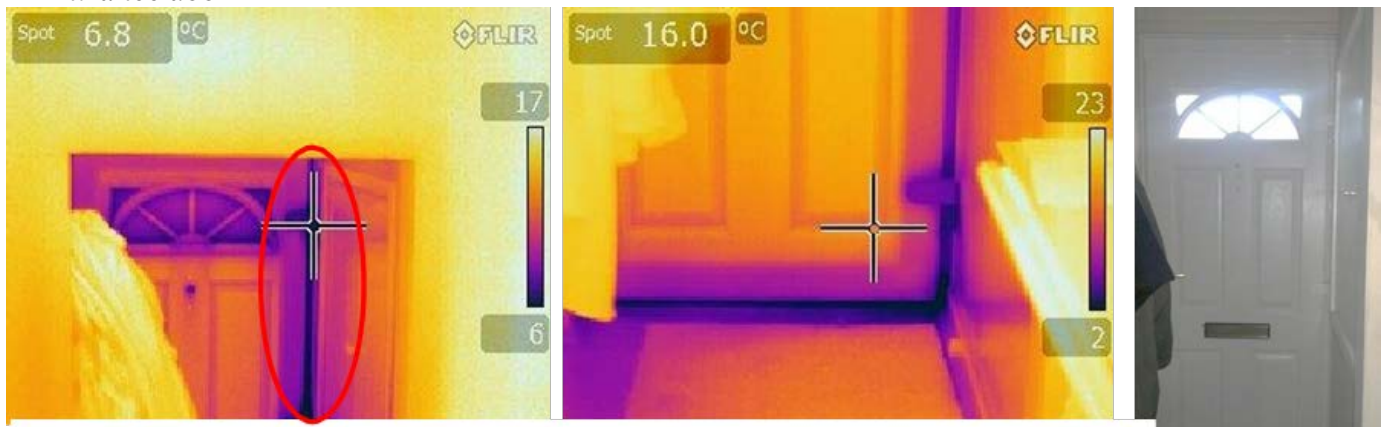
Figure 19: Investigation of entrance door under thermography

The black area (Figure 19) represents the area where the cold area is due to air infiltration, this is related to the defective seals on the top and bottom of the door profile.

By comparing these varying temperatures around the image, it is possible to identify cold air ingress in between the doors, and infer that by weatherproofing, comfort in that part of the home can be improved and energy costs reduced.

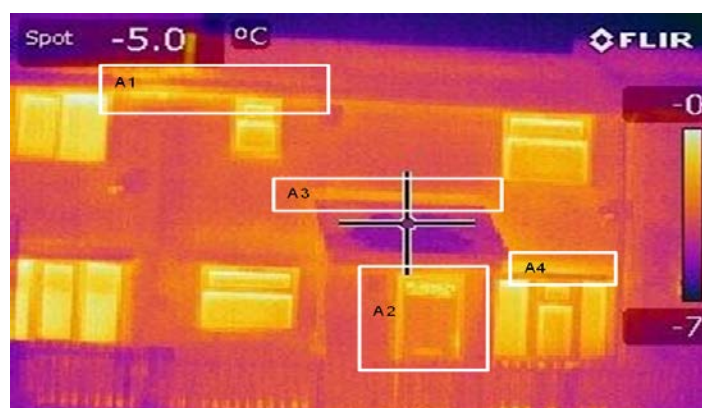
Figure 22: Thermography photo of the elevation walls.

Area 1 shows a comparative increase in surface temperature, due to missing/poorly fitted loft insulation at the eaves of the roof.

Area 2 is showing an increase in surface temperature around the door frames, possibly due to defective seals around the window openings allowing warm air to escape.

Area 3 is showing an increase in the temperature above and around the extension area and this is due to poor/ missing insulation in the joints which leads to heat loss.

Area 4 shows a comparative increase in surface temperature which is likely due to the window lintels creating a thermal bridge.

The temperatures of the windows appear to vary as well. Consider area 6, which looks to be cooler than area 5. Given that the two windows are in the same room and have the same temperature, the variation in infrared radiation is caused by infrared reflection from buildings on the opposite side of the road. They primarily measure infrared radiation, and various factors such as humidity, distance from the item, object emissivity, and reflection of infrared radiation from other sources can all influence the findings.
