## Accessibility of Visually Impaired Passengers at Urban Railway Stations in the Klang Valley

Ensuring access to the built environment and public transportation is a crucial element in reducing the mobility constraints of people with disabilities. This study intends to investigate the accessibility of visual impaired passengers regards to interior design of Kelana Jaya Line LRT station. The access audit was evaluated at core area, transition area and peripheral area of selected LRT stations by using site observation and interview research method. A standard checklist was taken in accordance to the Malaysia Standards Code of Practice for Access of Disabled People to Public Buildings (MS1184:2002). The result shows that, although most of the stations accommodate access for disabled people however the design of facilities provided was not fully incorporate with standard requirement and user-friendly. These lead barriers to independent living for persons with disability. As a conclusion, aside from providing a complete of public access facilities, comprehension of social sensitivity and capability to plan for continuity and uniformity should be taken into consideration to eliminate t

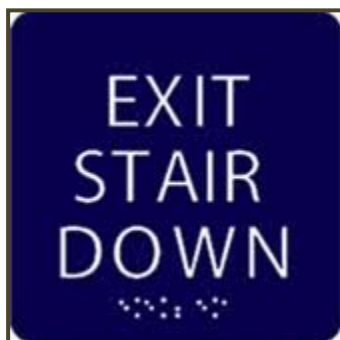
**Figure 5:** Signage in Braille (Source: [www.life4hire.berceloteh.com/caring](http://www.life4hire.berceloteh.com/caring)).

The requirements for signs and symbols are referred from MS1184 (2002), 28. Signs and Symbols. The size of the symbol and the height of lettering used for signage play an important role to ensure that the information can be presented clearly. The height of letters varies based on viewing distance. Signs with Braille or embossed lettering, as shown in Figure 5 and Figure 6, will be very helpful to the blind or those with low vision. In addition to this, as reported by Wurm *et al.* (1993), colour differences enable people to get more reliable

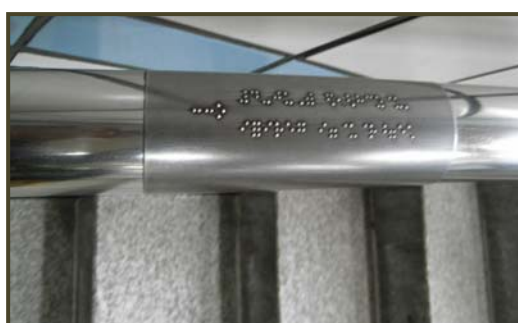
**Figure 6:** Braille Lettering at Hand Rail (Source: Individual photo collection).

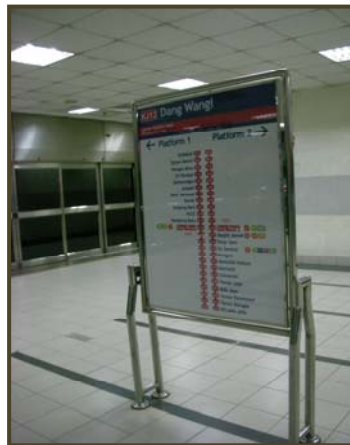
Most of the directional signage is shown after the ticketing counter except for stations with island platforms. The directional signage for station with island platforms is only available at the platform area. There is no directional signage in Braille or embossed lettering (See Figure 7). Therefore, the visual impaired passengers may need assistance to guide them to the correct platform.

**Figure 7:** Directional signage at the platform area at the Dang Wangi Station.

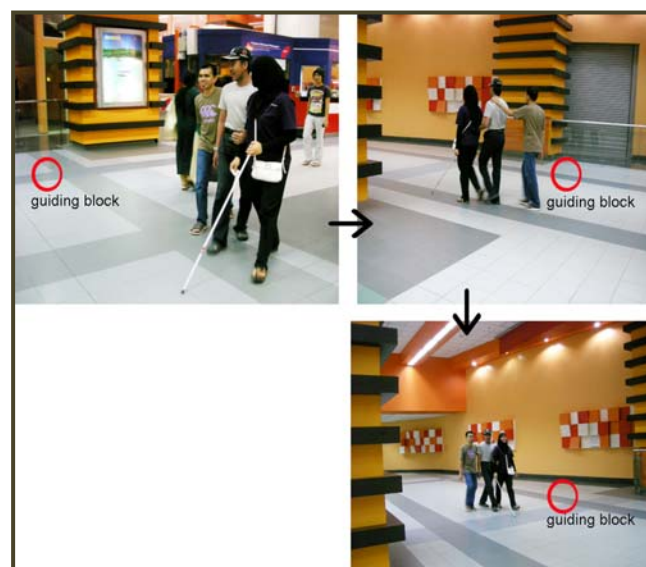
During the site observation, there were a few visually impaired passengers who had difficulties in their wayfinding from the platform to the AFC gate line exit as they lost the guidance path (see Figure 8). Besides this, there were also some visually impaired passengers who did not use the designated route for the disabled but instead, used the staircase as a

**Figure 8:** Wayfinding by visually impaired passengers at the Ampang Park Station.

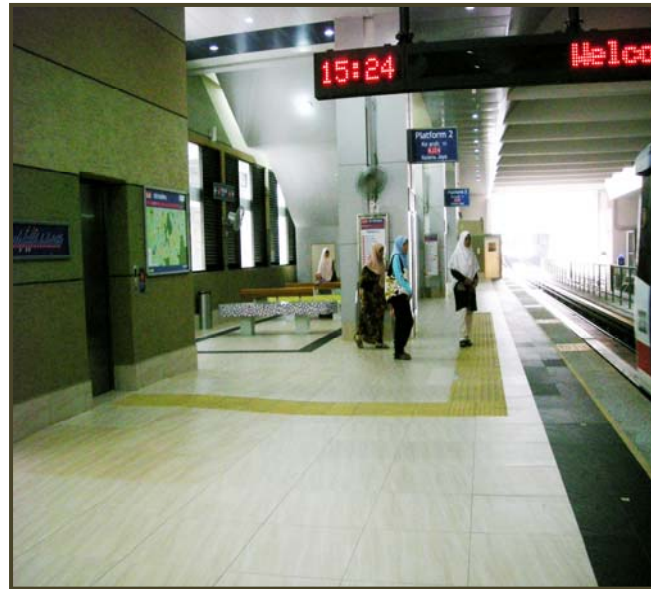
The designs of the platforms vary from the side platform and the island platform. The island platform is a single platform serving two tracks passing on either side. The side platform is usually determined by two platforms with double tracks of railway lines. The size of the platforms is almost similar for each type and has enough space for movement. Most of the guiding blocks are provided in front of the elevators (see Figure 9). However, the guiding blocks may not be provided along the tracks for every station. Although some platforms are complete with guiding blocks, the type and the size of the tactile are inconsistent and may not be according to the Malaysian Standard Code of Practice MS1184 (2002).

**Figure 9:** Guiding blocks at the platform area.
