## Structural Strength Evaluation by NDE and Load Test of RC Slab Structure, Case Study: RC Deck Slab of Primary Hospital Building, Faculty of Medicine, Thammasat University, Thailand

<sup>a</sup> Department of Civil Engineering, Faculty of Engineering, Thammasat University, THAILAND

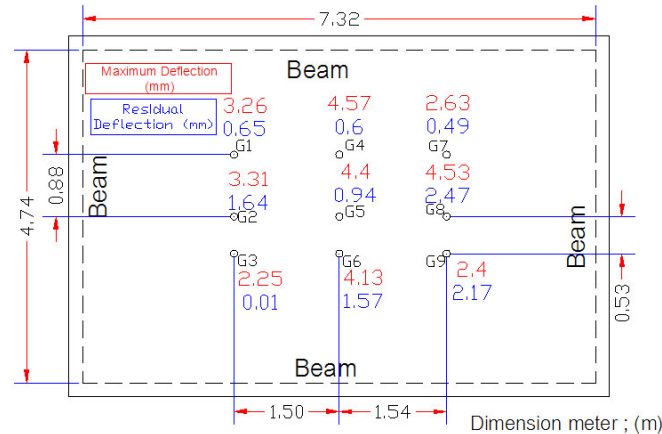
Figure 1: Location of Dial Gauges.

The dimensions of the tested deck slab is 7.32 x 4.74 m. (length x width) and its thickness is 15 cm. The nine dial gages are installed at the points G1 to G9 and the dial gage no.5 (G5) is located at the middle of the slab as shown in Figure 1.

1. Test the concrete strength by Schmidt Hammer (Rebound Hammer) that is an NDE testing-- before Load Test
2. Install the dial gauges no.1 to 9 (G1- G9) onto the deck slab structure for nine points that are located as shown in Figure 1 and the dial gage no.5 (G5) is installed at the middle of the

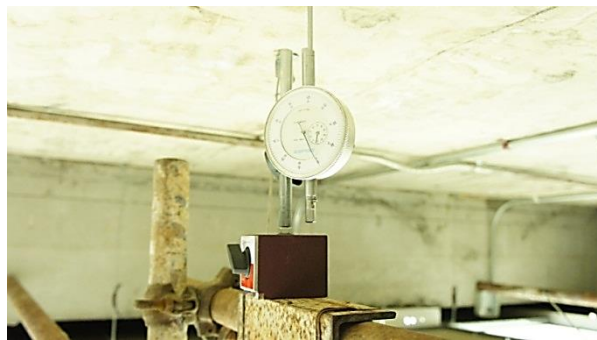
**Figure 2:** Dial Gauge and Magnetic Holder.

slab. The dial gage installation is used the magnetic base (shown in Figures 2) and shown in Figure 3 as well.

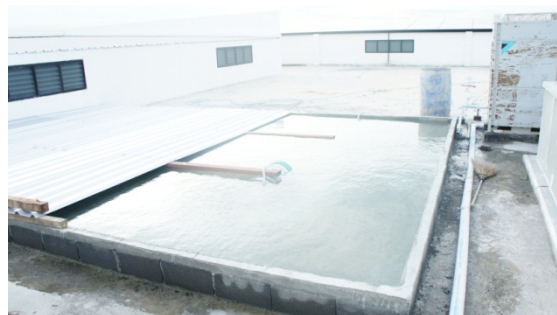
**Figure 4:** Loading by Water.

3. Record all initial deflections and the temperature prior the testing
4. Increase the load (water weight) step by step from 0%, 25%, 50%, 75%, and 100% of the maximum test load and each load step is held for 1 hour (for this deck slab structure, the design maximum live load equals 200 kg/m<sup>2</sup>)
5. Except the maximum test load (100%) that has to maintain 24 hours (shown in Figure 4)
6. After 24 hours, the test load is decreased step by step from 0%, 50%, and 100% of the maximum test and each released load step is held for 1 hour.
7. After release all test load, it is maintained for 24 hours.

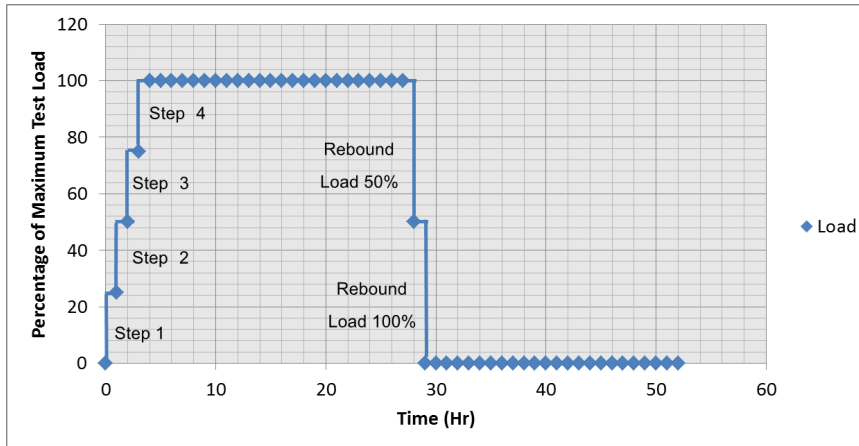
**Figure 5:** Graph Relationship between Time and Loading Percentage.

The testing results from Schmidt Hammer (NDE) are reported in Table 1 and the results from the load test are shown by the table and graph as Table 2 and Figure 5 respectively.

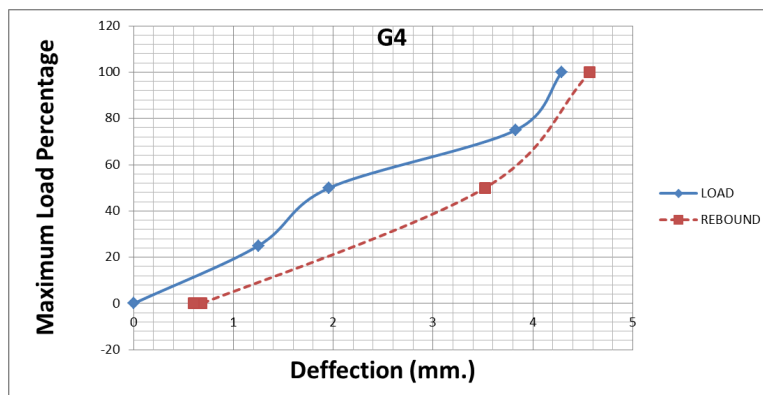
**Figure 6:** Relationships between Deflection and Maximum Load Percentage for Dial Gauge No.4.

The graph, that is shown in Figure 6, show the relationships between the deflection of the maximum slab deflection for the dial gage no.4 (G4) is 4.57 mm and the rebound deflection is to 0.6 mm. For the dial gage no.9 (G9), the maximum slab deflection is 2.4 mm and the rebound deflection is 2.17 mm as shown in Figure 7. From the load test results, all maximum deflections ( $\Delta_{max}$ ) from the testing must be less than the calculated deflection that is 8.33 mm. (calculated from Equation (2)) and the rebound deflections must be less than the calculated rebound deflections that are shown in the last column of Table 3 as well. This building has been suggested for repair because some rebound deflections still exist in the slab structure as shown in Table 3.
